***Chabot – Las Positas
Community College District
Facilities Modernization Program***

ASSESSMENT REPORT

Assessment of Existing Facilities

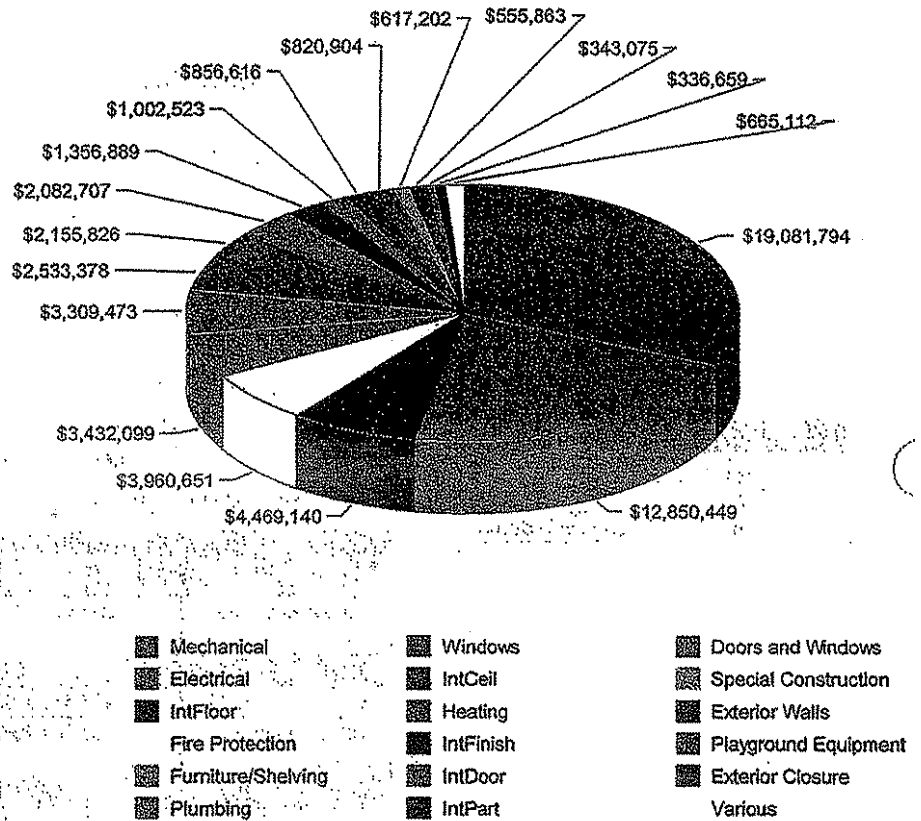
Estimate by Building System - Chabot-Las Positas CCD

The following chart gives a breakdown of the recorded deficiencies by their respective building systems for the entire district.

In general, the majority of the costs identified in the assessment are for mechanical, electrical and systems. Within mechanical systems, most costs are for adding or replacing chillers, boilers, and associated components such as air handlers and ductwork. The majority of the electrical system costs are for replacing lighting fixtures and providing additional capacity to the main service and branch circuits.

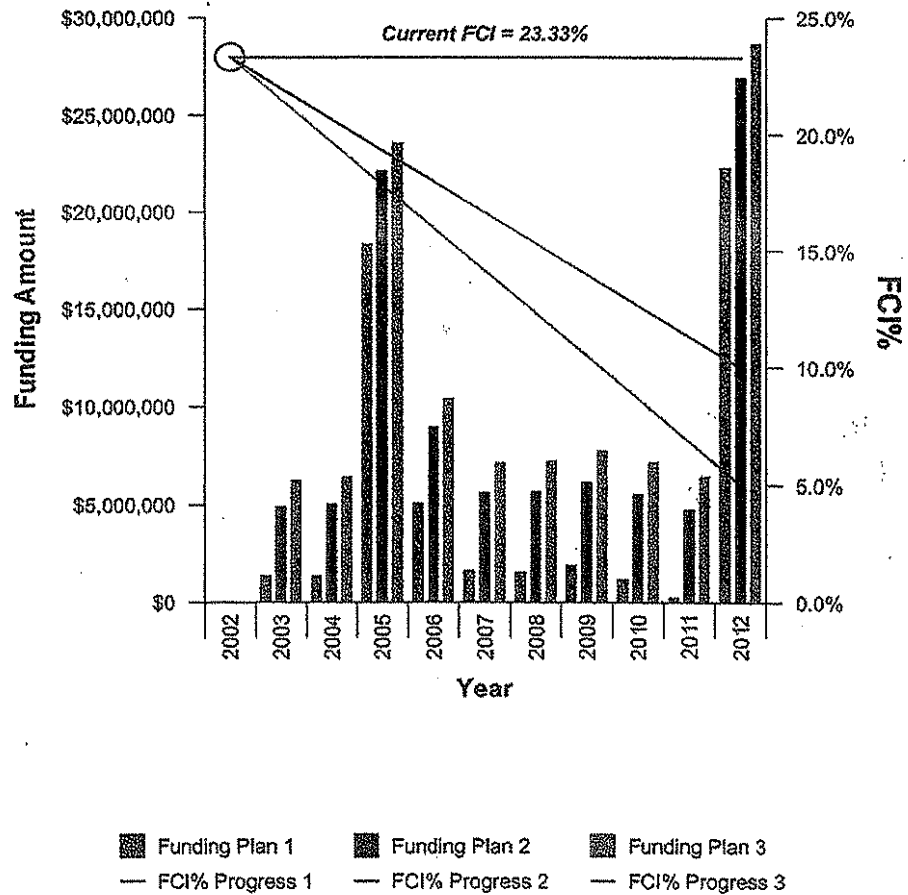
Future Facility Funding vs FCI for Chabot-Las Positas CCD

The following chart illustrates the 10-year total funding requirements for the Chabot-Las Positas Community College District for three (3) funding scenarios. It shows the combined funding needed for correcting the assessed deficiencies and the predicted capital renewal requirements. Using this chart, we can query:

Three scenarios are shown:

- **Current FCI: Keep the current FCI Stable (Red)**

The red line assumes no spending in the current year (2002) for current deficiencies. Capital renewal costs, as shown, over the next 10 years would be required to maintain the current FCI. The total funding required over 10 years is \$55,032,879.20.

- **Required funding: Reduce the FCI to 10% (Blue)**

The blue line assumes no spending in the current year (2002) for all current deficiencies. It assumes a consistent level of funds for the next 10 years to buy-down the current deficiencies and additional funding for capital renewal items to achieve an FCI of 10%. (Minimal standard as published by APPA.) The total funding required over 10 years is \$95,802,324.18.

- **Required funding: Reduce the FCI to 5% (Green)**

The green line assumes no spending in the current year (2002) for all current deficiencies. It assumes a consistent level of funds for the next 10 years to buy-down the current deficiencies and additional funding for capital renewal items to achieve an FCI of 5%. The total funding required over 10 years is \$111,095,068.18.

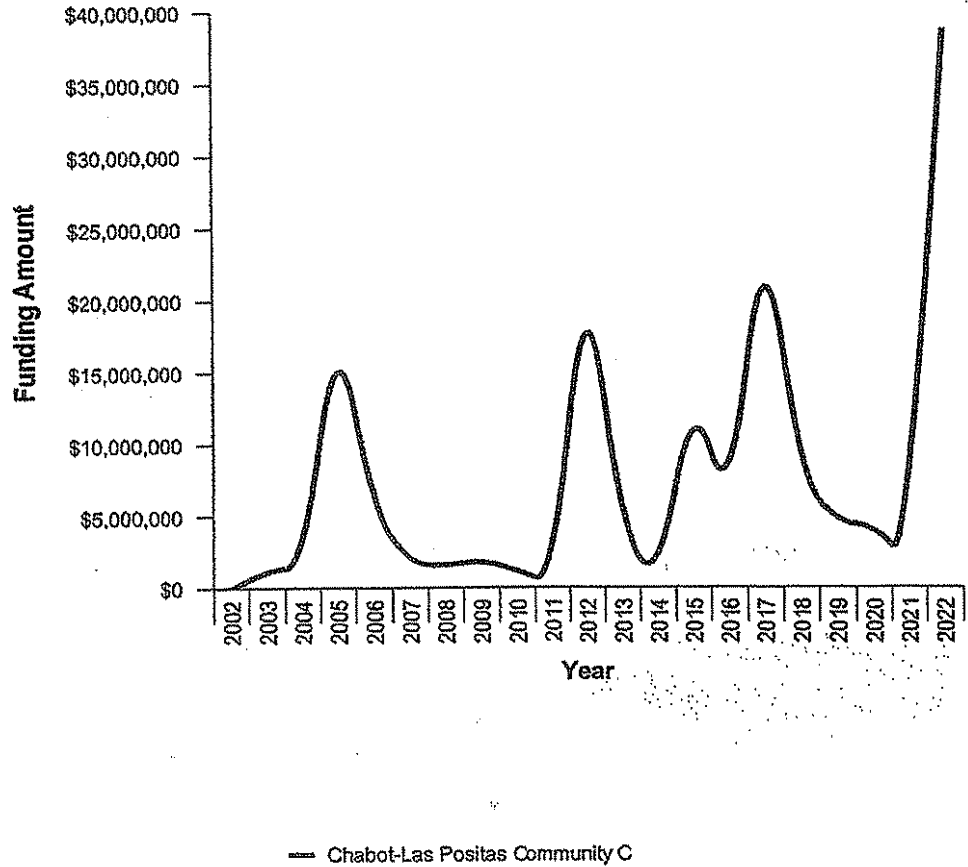
Facility Renewal Forecast for Chabot-Las Positas CCD

20 Year Capital Renewal Forecast

The cost models for each building give us a method to predict future needs for capital renewal. Each model allows us to assess the remaining life of each of the main systems in the building and to enter the expected time of replacement of such systems. Although each model is only a rough approximation for one building, over a larger sample size use of these cost models produces a reliable estimate of the yearly cost to replace building systems. This chart illustrates a 20-year projection of capital renewal funding requirements, excluding current deficiencies for the entire district
